A Summary of Earthquake Reconnaissance Efforts of the Multidisciplinary Center for Earthquake Engineering Research

MCEER RESPONSE

PRELIMINARY REPORTS FROM THE KOCAELI (IZMIT) EARTHQUAKE OF AUGUST 17, 1999

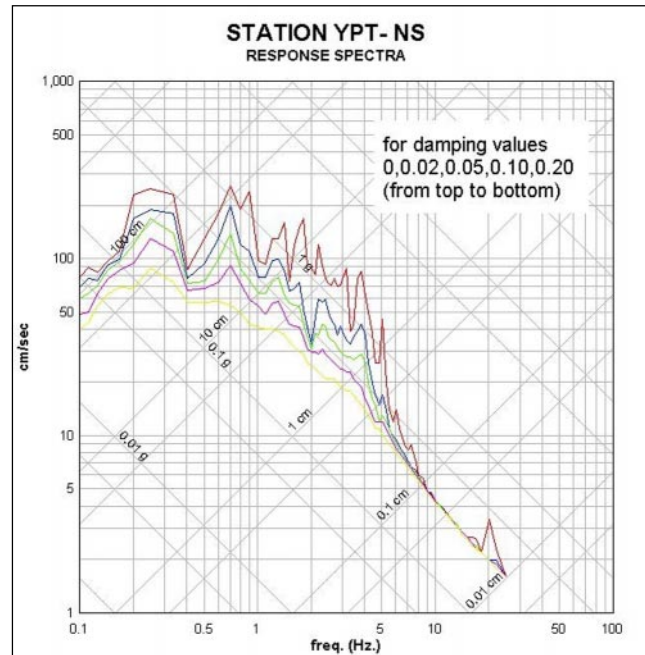
Response Spectra for NS component of YPT accelerogram. (Source: <http://www.koeri.boun.edu.tr/earthqk/earthquake.htm>)

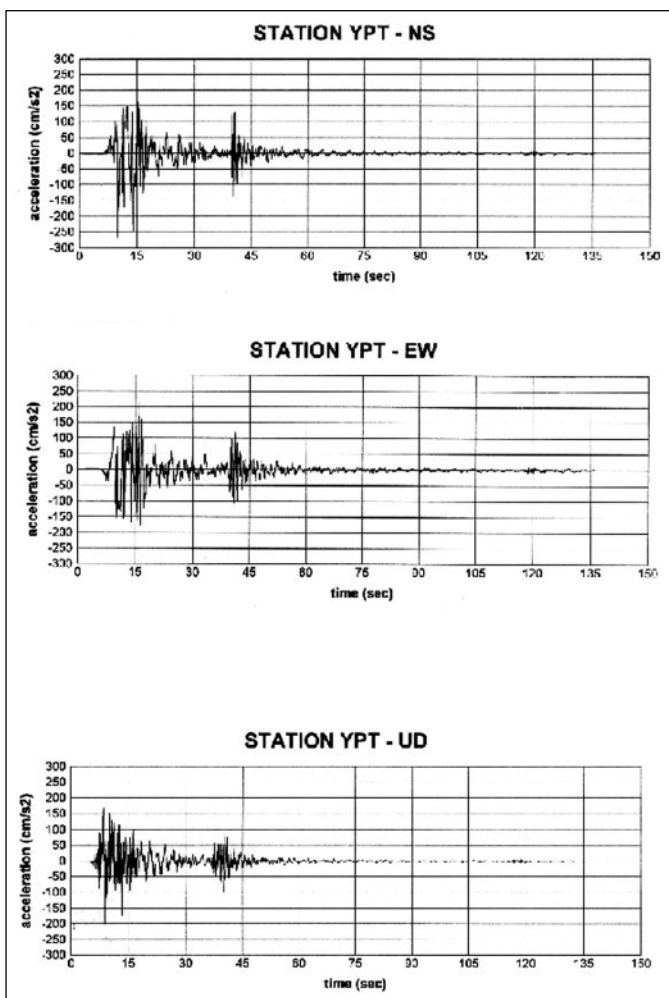
Accelerogram recorded at the Yarmca petrochemical complex (YPT) on the north shore of Izmit Bay, approximately 4 km from the fault trace. (Source: <http://www.koeri.boun.edu.tr/earthqk/earthquake.htm>)

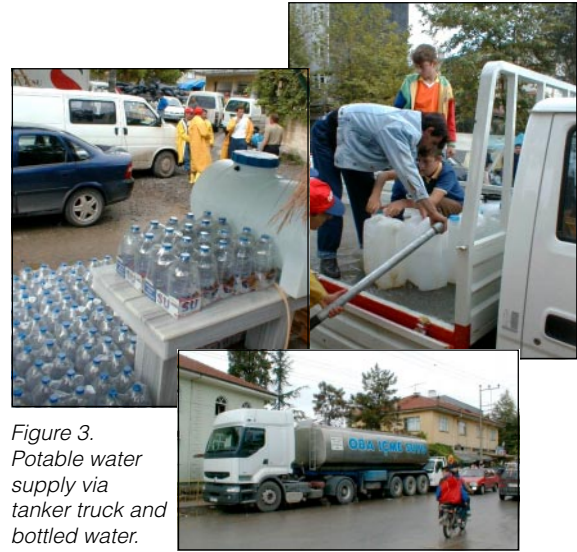
Figure 3. Potable water supply via tanker truck and bottled water.

Izmit water treatment plant and from several naval vessels in the Bay, and by bottled water, Figure 3.

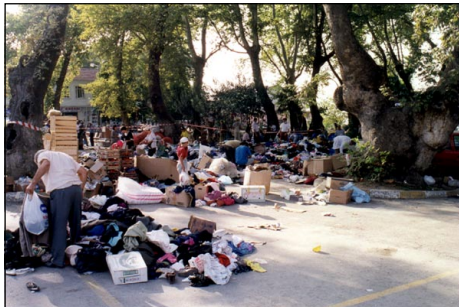
Many donations were sent to the affected areas, but there was no organized distribution system.
